Catalina Pueblo HOA
Tucson, AZ

Report #: 26870-1
Beginning: January 1, 2025
Expires: December 31, 2025

RESERVE STUDY
Update "With-Site-Visit"

July 19, 2024

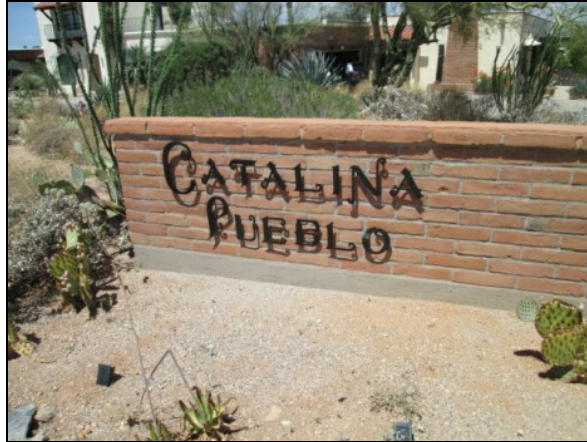
Comments: Appears to be intact and functional, but older and dated. Recommend planning to refurbish/remodel soon to update/modernize the appearance. This component funds an allowance to refurbish/remodel the monument.

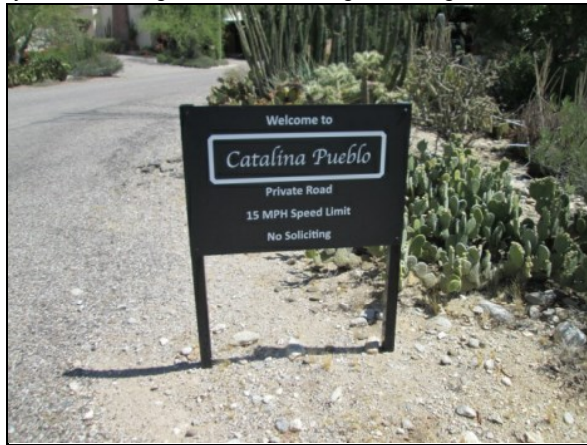
Comp #: 104 Signs - Replace**Quantity: Approx (4) Signs**

Comments: Appear to be relatively newer. No significant weathering or damage evident.

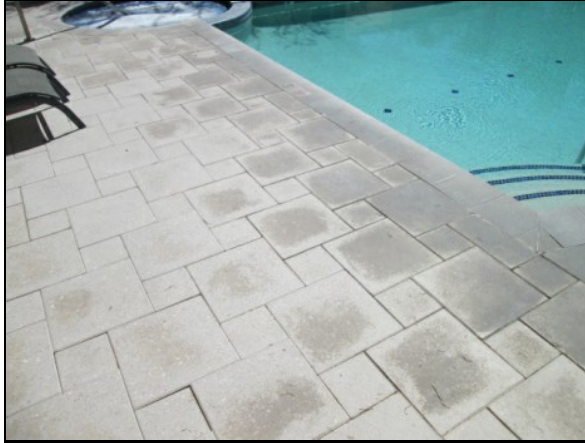
Comments: The old acrylic pool deck has been replaced with a travertine paver deck. Appears to be intact and in fair shape overall. There is a section along the pool and spa that is stained and discolored. This component funds to completely replace the paver deck.

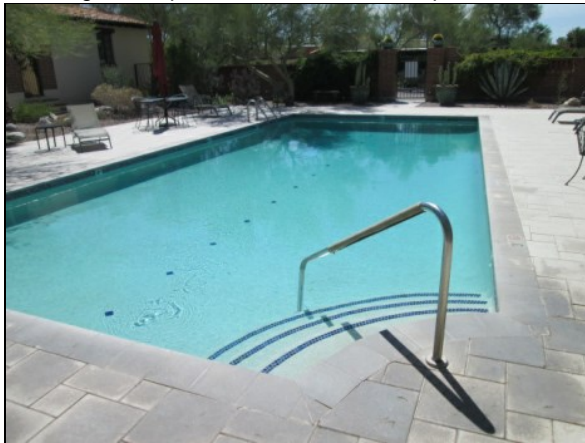
Comments: The pool has a pebble surface with waterline tile. Appears to be intact with no significant wear or damage evident. Pebble surfaces are expected to last longer than plaster surfaces. This component funds to resurface with pebble.
