## “Full” Reserve Study

## Catalina Pueblo HOA Tucson, Arizona

**Report #: 26870-0**  
**For Period Beginning: January 1, 2015**  
**Expires: December 31, 2015**  
**Date Prepared: June 26, 2014**

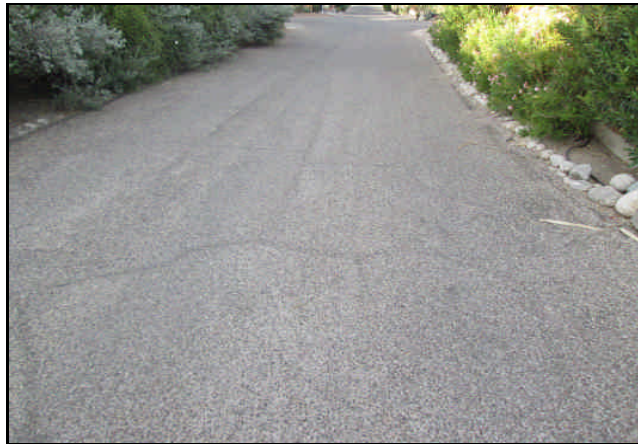
Useful Life:  
40 years

Remaining Life:  
4 years

Best Case: \$170,000  
Estimate to repave

Worst Case: \$230,000  
Higher estimate

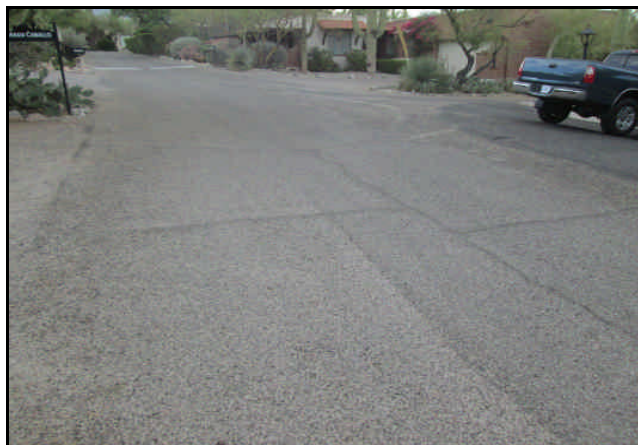
Useful Life:  
8 years

Remaining Life:  
5 years

Best Case: \$34,000  
Estimate to chip seal

Worst Case: \$44,000  
Higher estimate

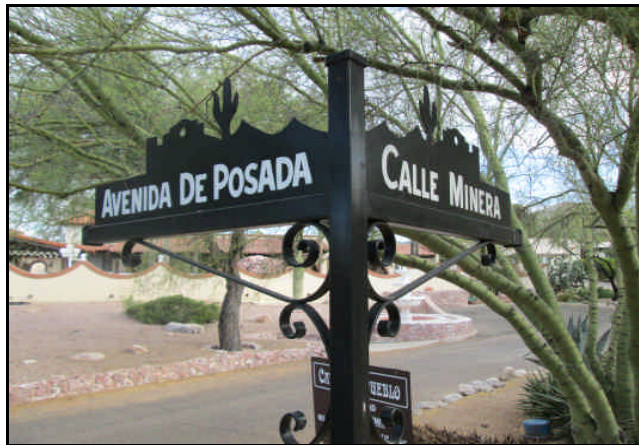
Useful Life:  
50 years

Remaining Life:  
15 years

Best Case: \$8,000  
Estimate to replace

Worst Case: \$10,000  
Higher estimate

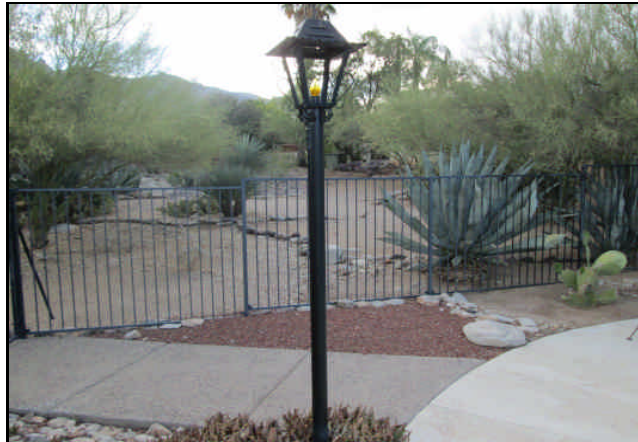
Useful Life:  
40 years

Remaining Life:  
10 years

Best Case: \$11,000  
Estimate to replace

Worst Case: \$15,000  
Higher estimate

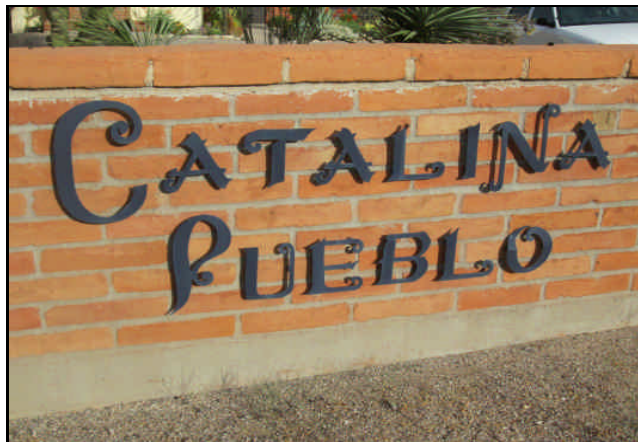
Remaining Life:

6 years

Best Case: \$1,800

Worst Case: \$2,400

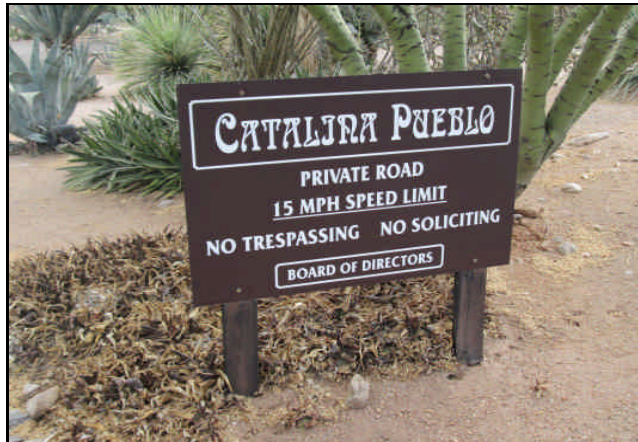
Useful Life:  
15 years

Remaining Life:  
3 years

Best Case: \$900  
Estimate to replace

Worst Case: \$1,100  
Higher estimate

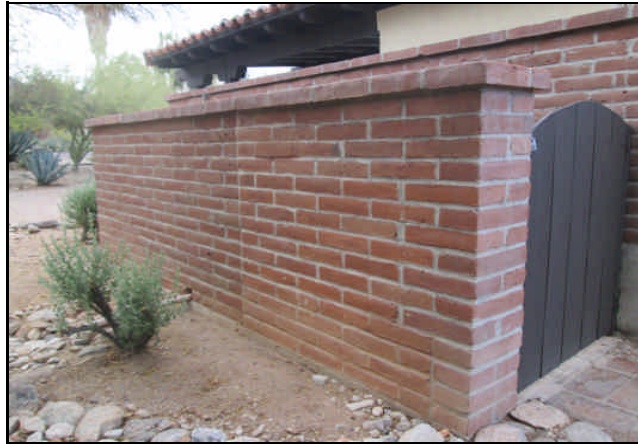
Useful Life:  
4 years

Remaining Life:  
0 years

Best Case: \$5,300  
Estimate to seal/repair

Worst Case: \$6,700  
Higher estimate

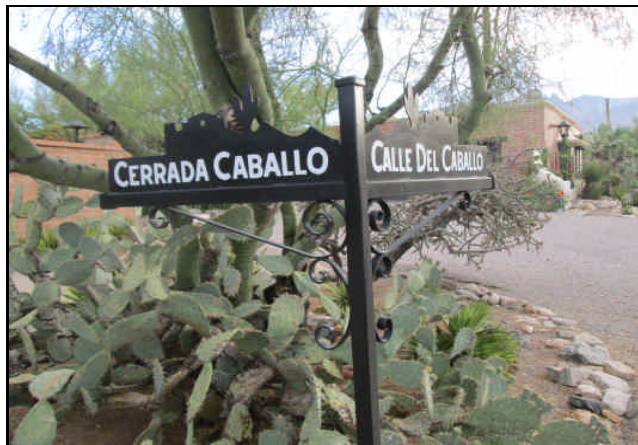
Useful Life:  
5 years

Remaining Life:  
1 years

Best Case: \$1,400  
Estimate to repaint

Worst Case: \$1,800  
Higher estimate

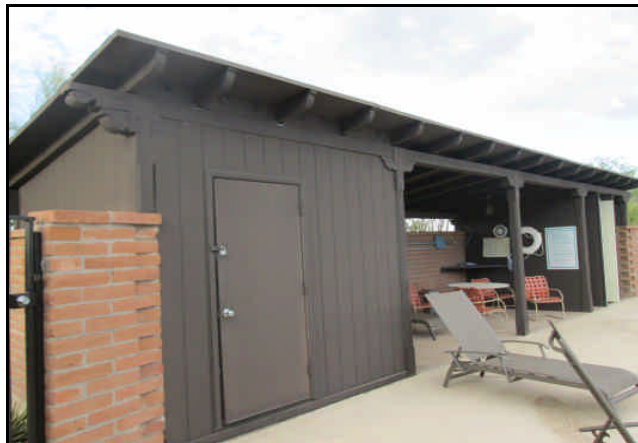
Useful Life:  
5 years

Remaining Life:  
1 years

Best Case: \$1,300  
Estimate to repaint/repair

Worst Case: \$1,700  
Higher estimate

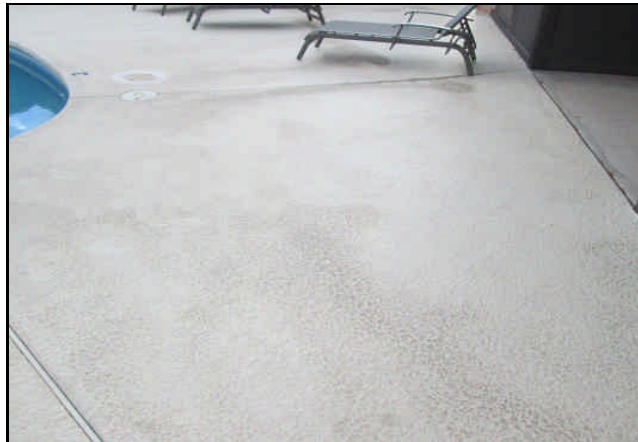
Useful Life:  
16 years

Remaining Life:  
8 years

Best Case: \$9,000  
Estimate to resurface

Worst Case: \$12,000  
Higher estimate

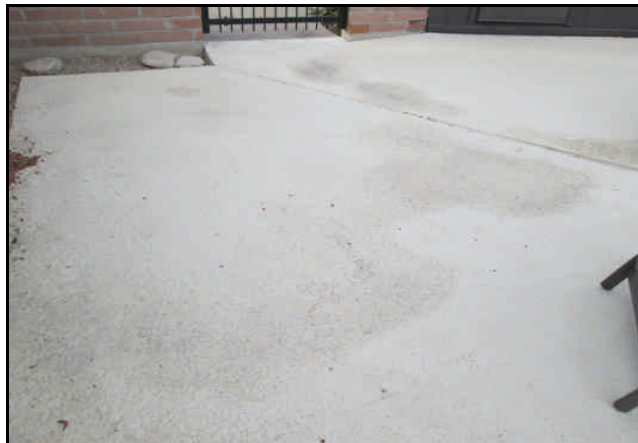
Useful Life:  
4 years

Remaining Life:  
0 years

Best Case: \$2,600  
Estimate to seal/repair

Worst Case: \$3,400  
Higher estimate

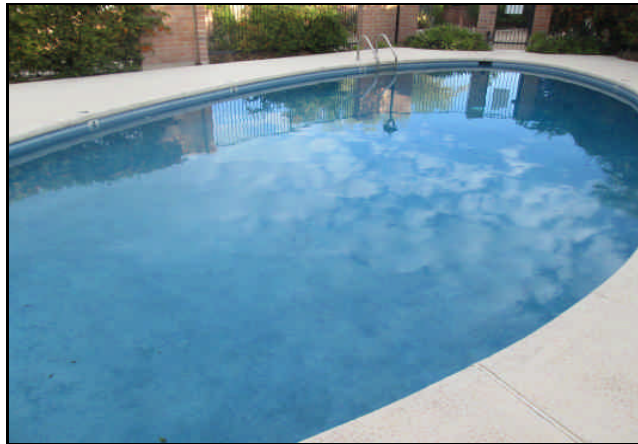
Useful Life:  
10 years

Remaining Life:  
2 years

Best Case: \$7,000  
Estimate to resurface

Worst Case: \$9,000  
Higher estimate

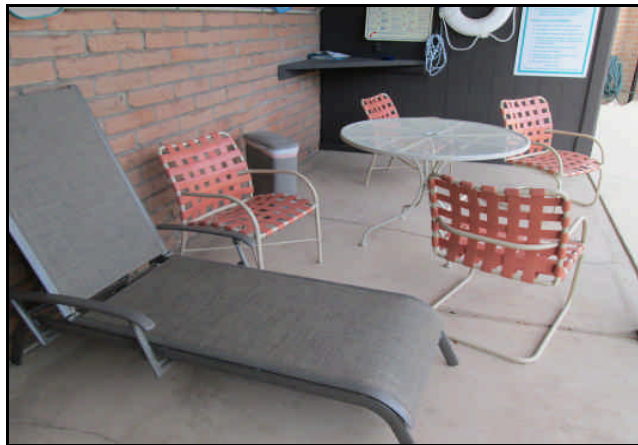
Useful Life:  
4 years

Remaining Life:  
2 years

Best Case: \$1,000  
Estimate for partial replacement

Worst Case: \$1,200  
Higher estimate

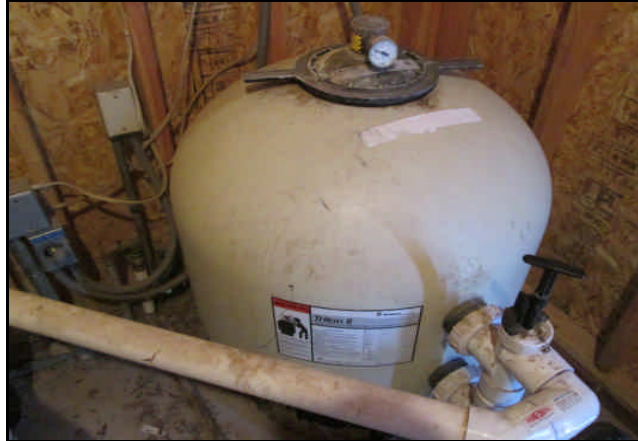
Useful Life:  
15 years

Remaining Life:  
7 years

Best Case: \$1,200  
Estimate to replace

Worst Case: \$1,500  
Higher estimate

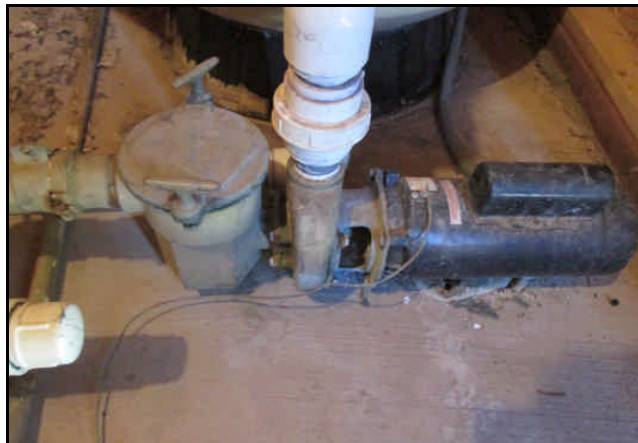
Useful Life:  
10 years

Remaining Life:  
0 years

Best Case: \$900  
Estimate to replace

Worst Case: \$1,100  
Higher estimate

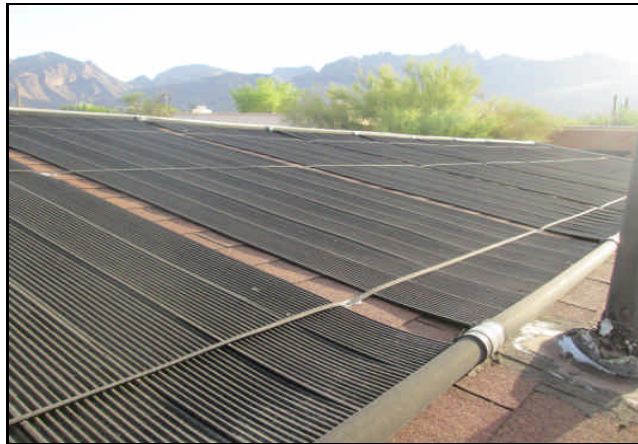
Useful Life:  
20 years

Remaining Life:  
14 years

Best Case: \$5,300  
Estimate to replace

Worst Case: \$6,300  
Higher estimate

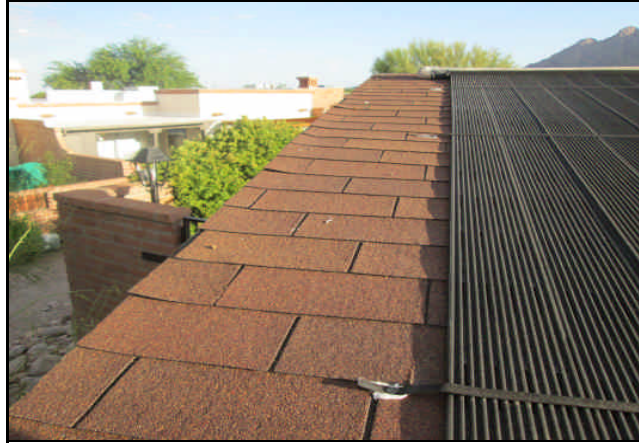
Useful Life:  
25 years

Remaining Life:  
10 years

Best Case: \$2,200  
Estimate to replace

Worst Case: \$2,800  
Higher estimate

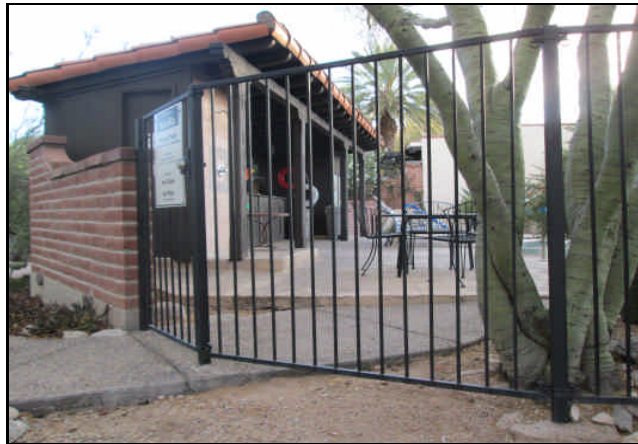
Useful Life:  
30 years

Remaining Life:  
8 years

Best Case: \$4,000  
Estimate to replace

Worst Case: \$5,000  
Higher estimate

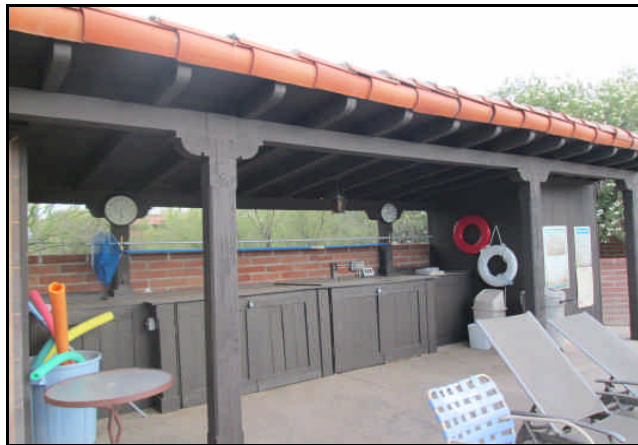
Useful Life:  
5 years

Remaining Life:  
1 years

Best Case: \$1,300  
Estimate to repaint/repair

Worst Case: \$1,700  
Higher estimate

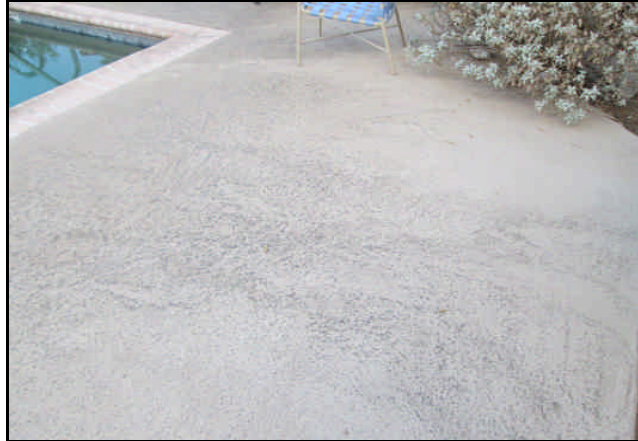
Useful Life:  
16 years

Remaining Life:  
0 years

Best Case: \$9,000  
Estimate to resurface

Worst Case: \$12,000  
Higher estimate

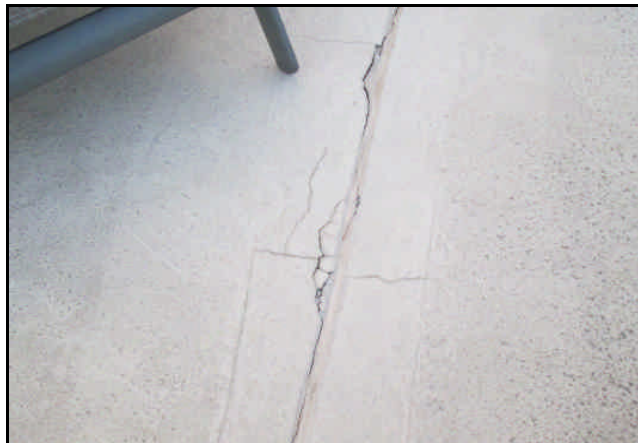
Useful Life:  
4 years

Remaining Life:  
4 years

Best Case: \$2,600  
Estimate to seal/repair

Worst Case: \$3,400  
Higher estimate

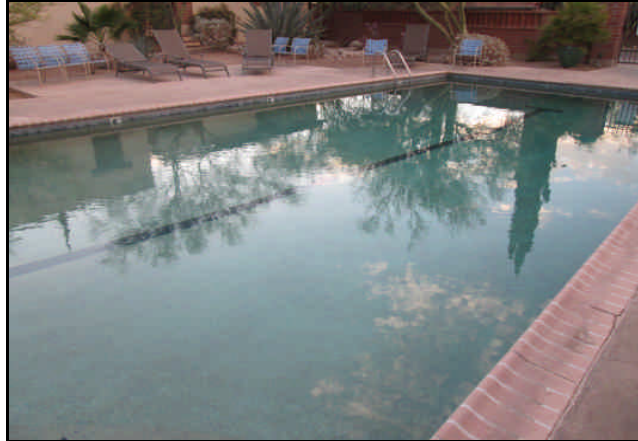
Useful Life:  
20 years

Remaining Life:  
0 years

Best Case: \$10,000  
Estimate to resurface

Worst Case: \$12,000  
Higher estimate

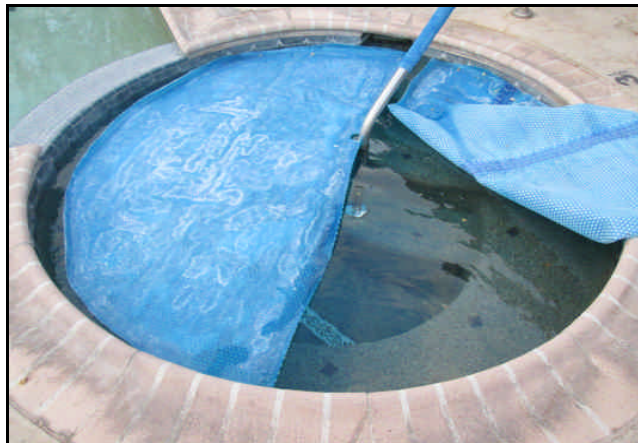
Useful Life:  
15 years

Remaining Life:  
0 years

Best Case: \$3,500  
Estimate to resurface

Worst Case: \$4,500  
Higher estimate

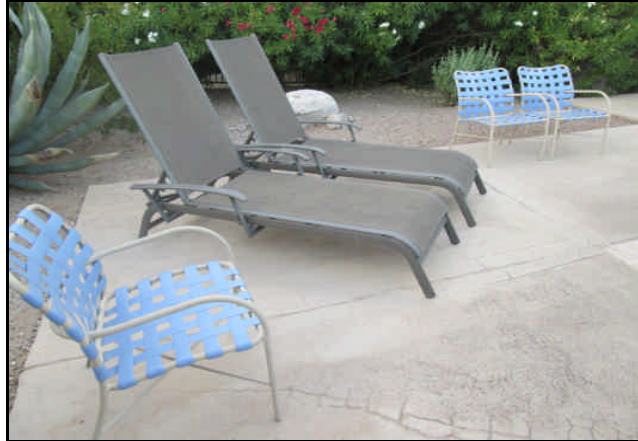
Useful Life:  
4 years

Remaining Life:  
2 years

Best Case: \$3,300  
Estimate for partial replacement

Worst Case: \$4,300  
Higher estimate

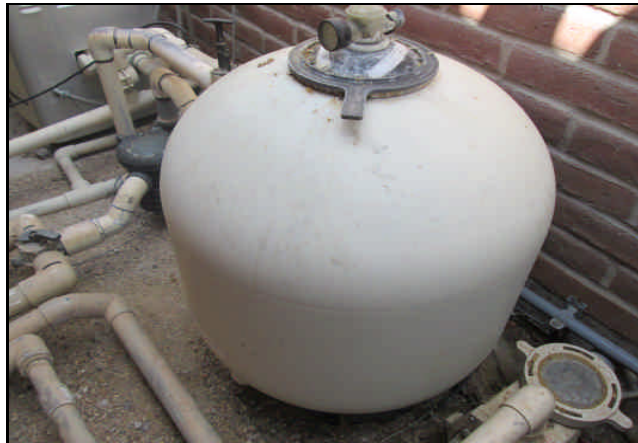
Useful Life:  
15 years

Remaining Life:  
3 years

Best Case: \$1,200  
Estimate to replace

Worst Case: \$1,500  
Higher estimate

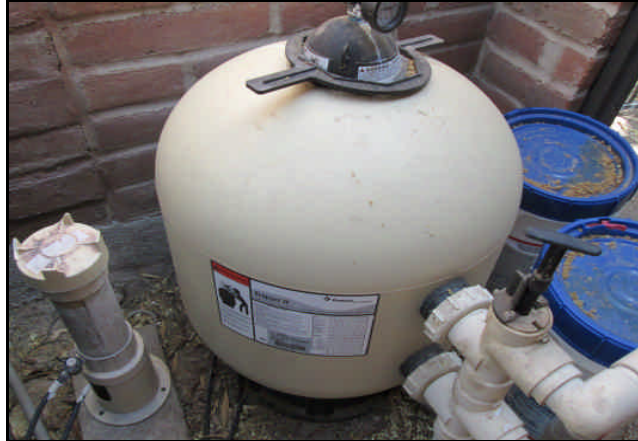
Useful Life:  
15 years

Remaining Life:  
13 years

Best Case: \$900  
Estimate to replace

Worst Case: \$1,200  
Higher estimate

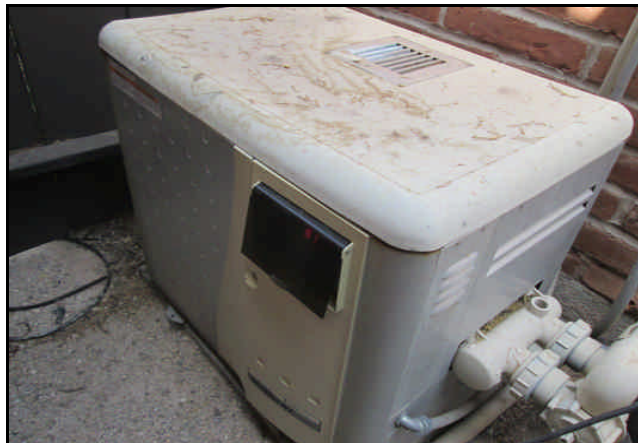
Useful Life:  
8 years

Remaining Life:  
0 years

Best Case: \$2,900  
Estimate to replace

Worst Case: \$3,500  
Higher estimate

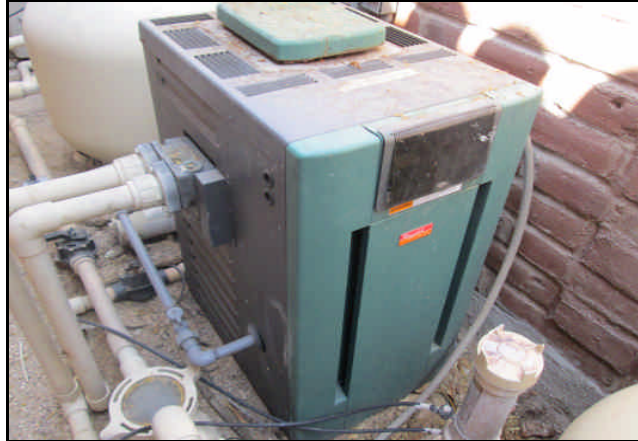
Useful Life:  
8 years

Remaining Life:  
0 years

Best Case: \$2,200  
Estimate to replace

Worst Case: \$2,800  
Higher estimate

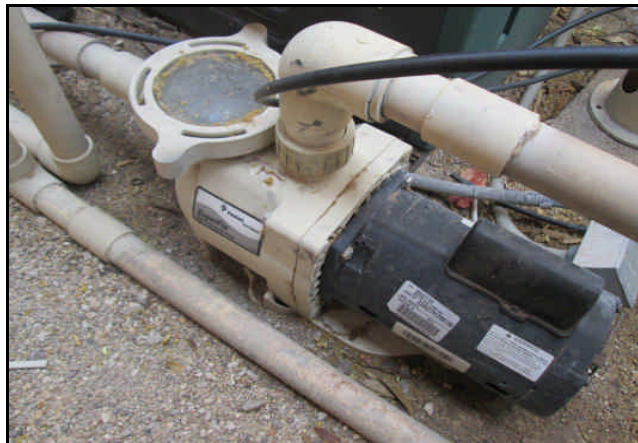
Useful Life:  
10 years

Remaining Life:  
3 years

Best Case: \$1,800  
Estimate to replace

Worst Case: \$2,200  
Higher estimate

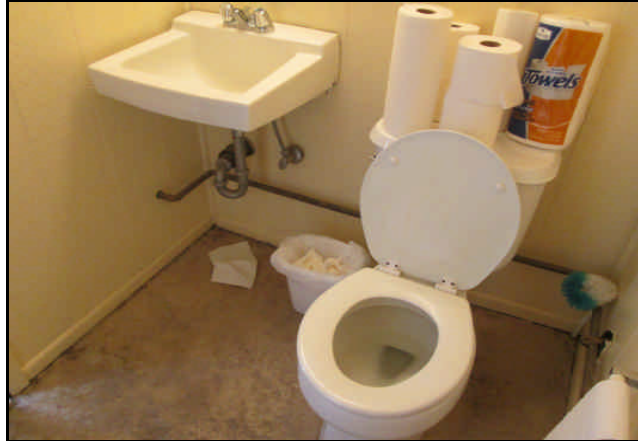
Useful Life:  
20 years

Remaining Life:  
9 years

Best Case: \$2,500  
Estimate to remodel

Worst Case: \$3,000  
Higher estimate

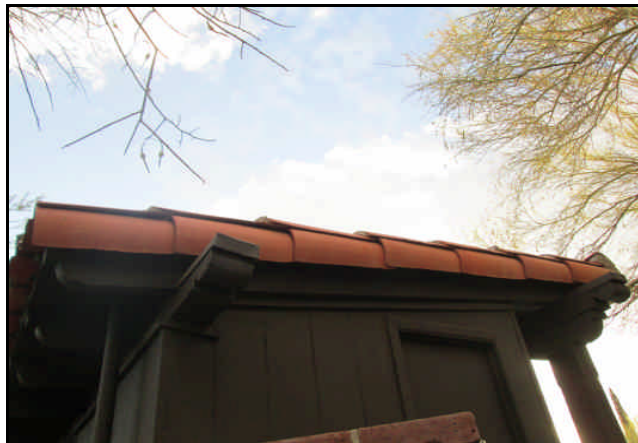
Evaluation : There is no expectancy to replace all of the tiles under normal circumstances. Replacement of the felt paper underlayment should be anticipated eventually. Life span will vary depending on the quality of underlayment installed.

Useful Life:  
30 years

Remaining Life:  
5 years

Best Case: \$1,500  
Estimate to remove tiles, replace underlayment,  
reinstall tiles

Worst Case: \$2,000  
Higher estimate

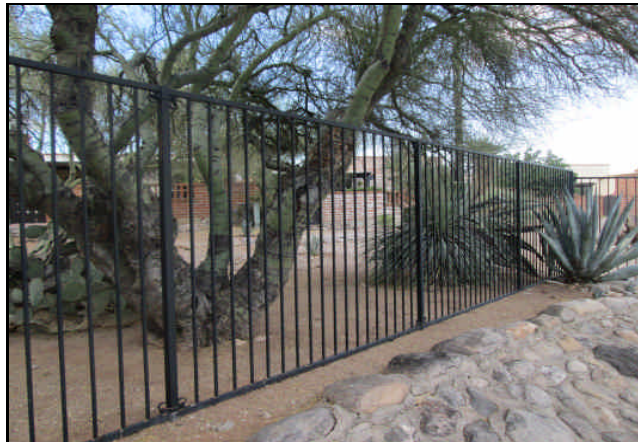
**Comp # : 503 Metal Fence - Replace**

Evaluation : Fence appears to be in fair condition. Appears older but still stable. Some rust issues evident. Repaint periodically as an Operating expense to maintain the appearance and to inhibit rust. Funding is provided for future replacement.

Useful Life:  
30 years

Remaining Life:  
8 years

Best Case: \$6,000  
Estimate to replace

Worst Case: \$7,000  
Higher estimate

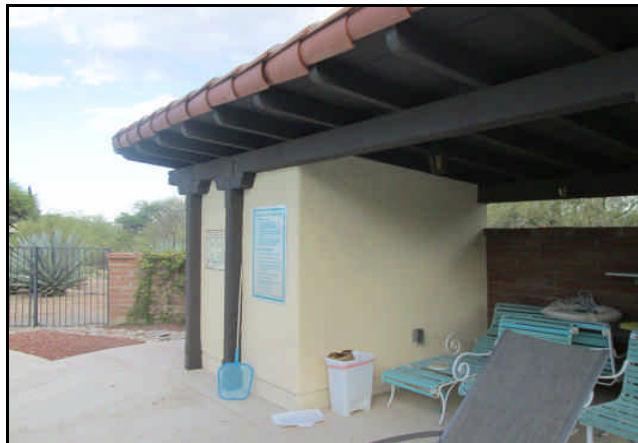
**Comp # : 1117 Pool Building - Repaint/Repair**

Evaluation : Funding is provided to periodically repaint and repair the pool building. Last repainted during 2011. Surfaces still appear to be in fair shape.

Useful Life:  
5 years

Remaining Life:  
1 years

Best Case: \$900  
Estimate to repaint/repair

Worst Case: \$1,100  
Higher estimate

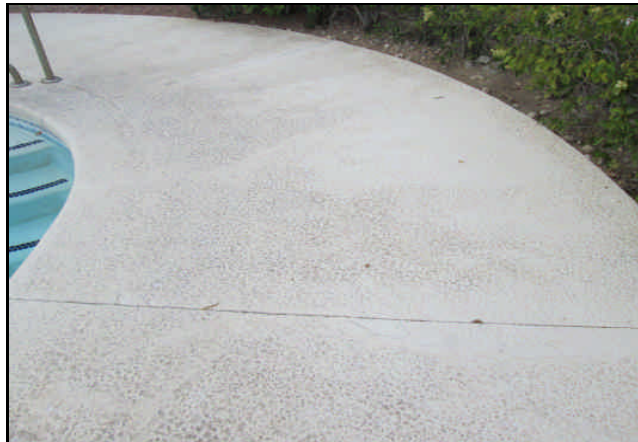
Evaluation : Expect to recoat, or resurface, the deck at some point in the future. Deck appears older with cracks and weathering evident. Life span is based on periodically sealing and maintaining the deck as scheduled.

Useful Life:  
16 years

Remaining Life:  
4 years

Best Case: \$6,100  
Estimate to resurface

Worst Case: \$7,500  
Higher estimate

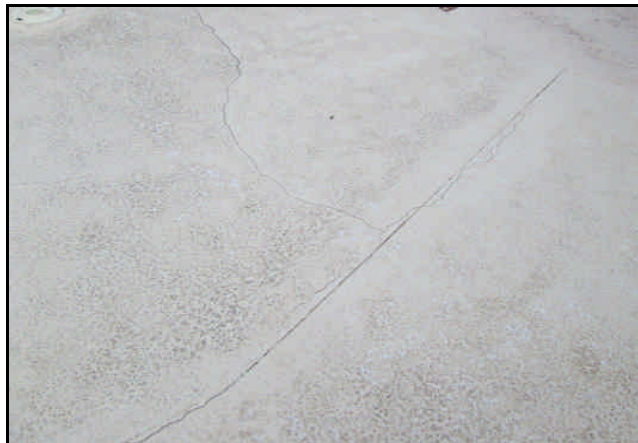
**Comp # : 1201 Pool Deck - Seal/Repair**

Evaluation : This component funds to periodically patch cracks and seal/paint the deck to cover stains and restore the appearance. Cracks and discoloration evident.

Useful Life:  
4 years

Remaining Life:  
0 years

Best Case: \$1,700  
Estimate to seal/repair

Worst Case: \$2,300  
Higher estimate

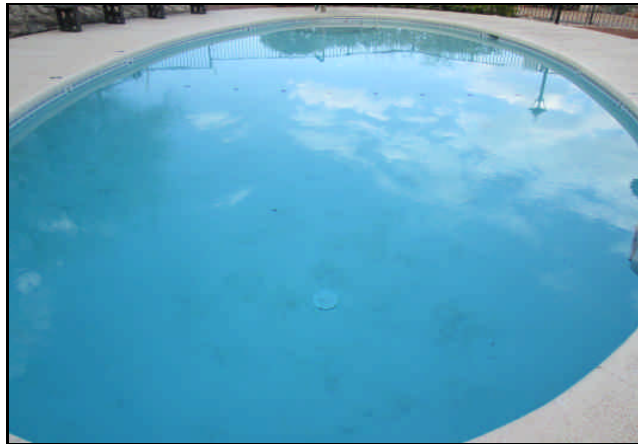
Evaluation : Pool was reportedly last resurfaced around 2006. Surfaces are plaster with waterline tiles. Discoloration evident, but appears to be in fair shape otherwise. Funding is provided to eventually resurface and retile the pool.

Useful Life:  
10 years

Remaining Life:  
2 years

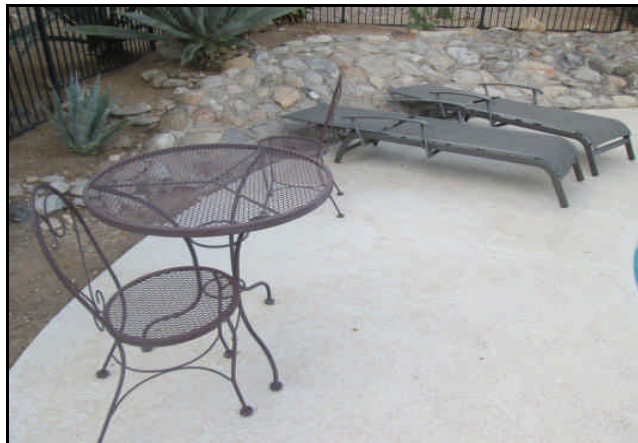
Evaluation : Pieces include (6) lounges, (6) chairs, (2) benches, and (2) tables. Varying conditions observed. There is no expectancy for complete replacement. Funding is provided for periodic, partial replacement.

Useful Life:  
4 years

Remaining Life:  
2 years

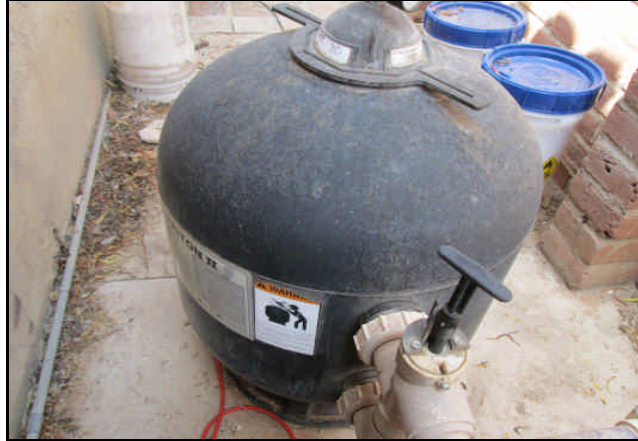
**Comp # : 1220 Pool Filter - Replace**

Evaluation : Filter appears older but functional. No problems reported. Future replacement should be anticipated. Serial: 06G.

Useful Life:  
15 years

Remaining Life:  
3 years

Best Case: \$1,200  
Estimate to replace

Worst Case: \$1,500  
Higher estimate

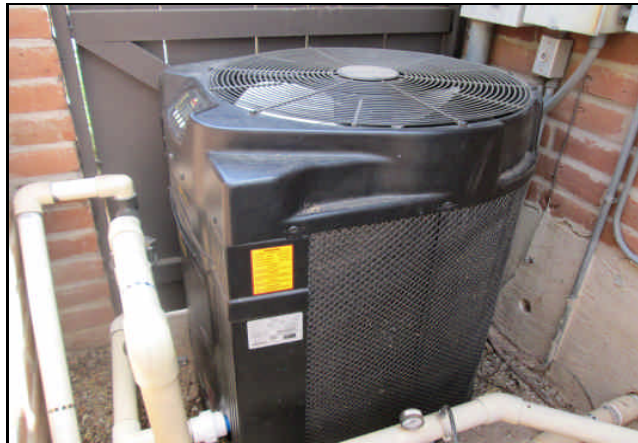
**Comp # : 1222 Pool Heater - Replace**

Evaluation : This is a large heat pump for the pool. Installed during 2012 for approximately \$12,000. Appears functional and in good shape. Future replacement should be expected. Model: 15SAHDSBTK, Serial: 1126152-K11.

Useful Life:  
10 years

Remaining Life:  
7 years

Best Case: \$5,800  
Estimate to replace

Worst Case: \$7,000  
Higher estimate

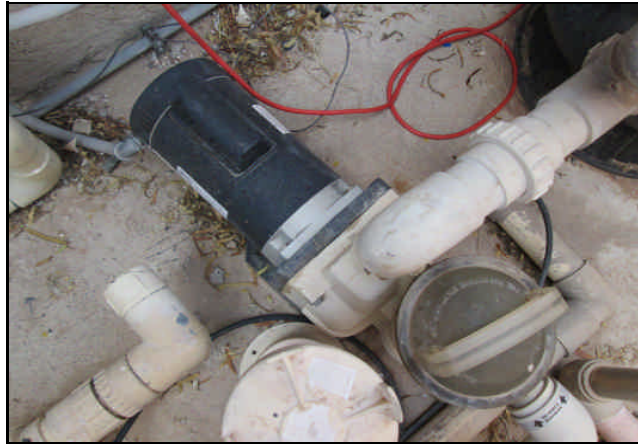
**Comp # : 1224 Pool Pump - Replace**

Evaluation : Pump appears older but functional. No problems reported. It should still be nearing time for replacement.

Useful Life:  
10 years

Remaining Life:  
1 years

Best Case: \$900  
Estimate to replace

Worst Case: \$1,100  
Higher estimate

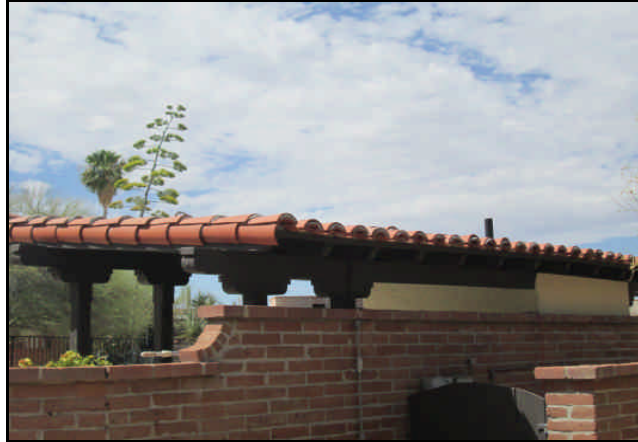
**Evaluation :** There is no expectancy to replace all of the tiles under normal circumstances. Replacement of the felt paper underlayment should be anticipated eventually. Life span will vary depending on the quality of underlayment installed.

**Useful Life:**  
30 years

**Remaining Life:**  
5 years

**Best Case:** \$1,300

**Worst Case:** \$1,700

Estimate to remove tiles, replace underlayment,  
reinstall tiles
