Catalina Pueblo HOA
Tucson, AZ

Report #: 26870-1
Beginning: January 1, 2025
Expires: December 31, 2025

RESERVE STUDY
Update "With-Site-Visit"

July 19, 2024

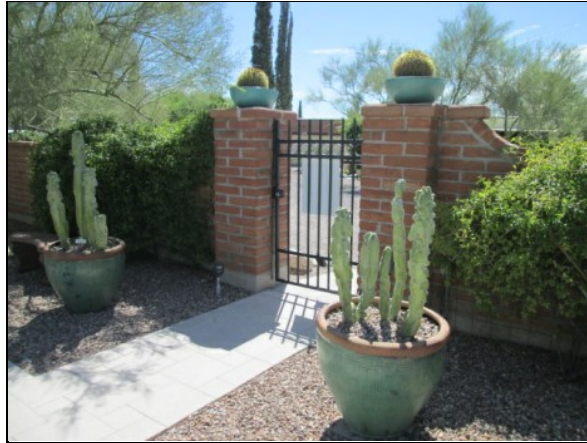
Comp #: 1206 Concrete Pots - Replace

Funded?: No. Cost is below the Reserve expense threshold. Recommend replacing as needed with Operating funds.

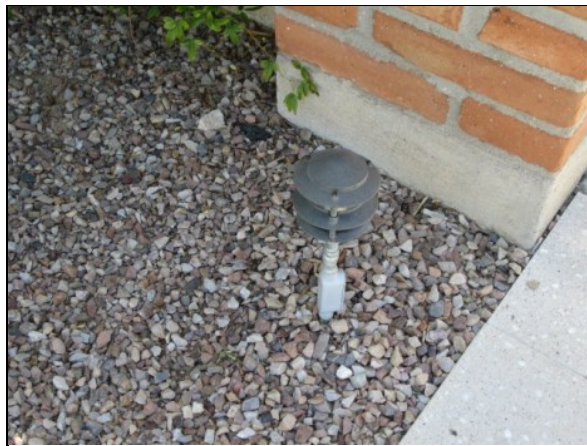
Comp #: 1208 Path Lights - Replace

Comments: Assumed to be functional with no issues reported. Funding includes replacement of the low-voltage transformer. Treat repairs and individual replacements as a maintenance expense. Expect to eventually replace all the fixtures to update and restore the lighting.

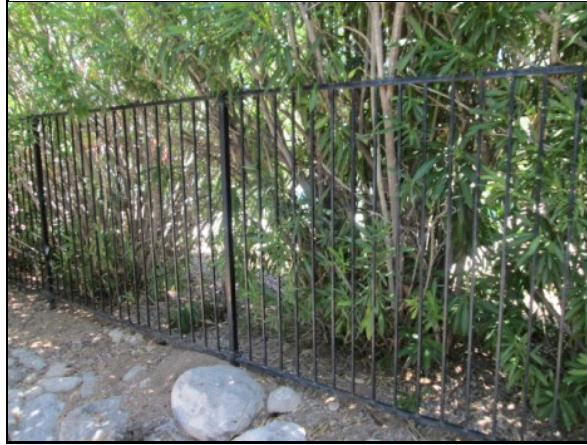
Comp #: 1210 Metal Fence - Replace

Comments: Appears to be intact and secure overall. No significant issues evident. Repaint periodically as an Operating expense to maintain the appearance and to inhibit rust. Replacement should be anticipated.

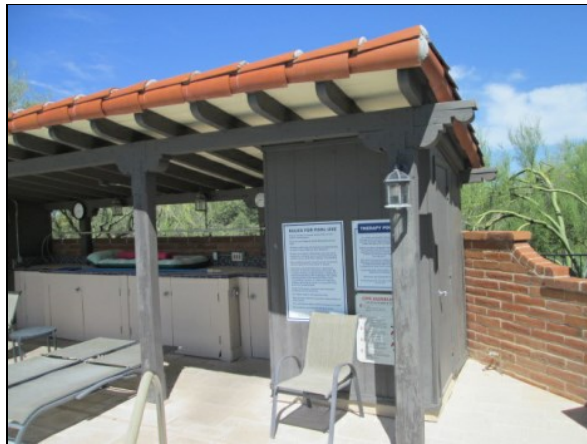
Comp #: 1214 Pool Building - Repaint/Repair

Comments: Surfaces appear to be weathered with fading and oxidation evident. This component funds to periodically repaint and repair the pool building.

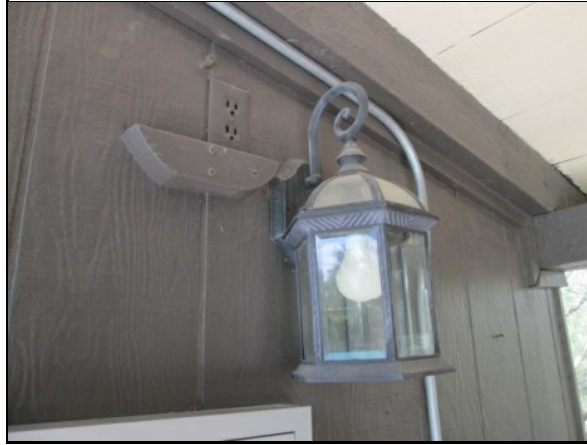
Comp #: 1216 Exterior Lights - Replace

Funded?: No. Cost is expected to be below the Reserve expense threshold. Recommend replacing as needed with Operating funds.

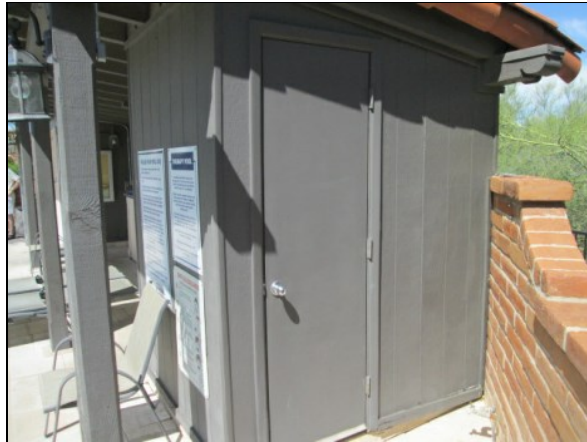
Comp #: 1218 Exterior Doors - Replace

Comments: Appear to be intact and functional. Replacement should be anticipated.

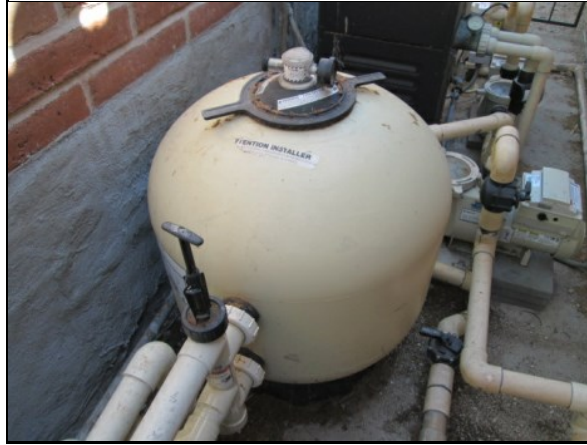
Comp #: 1220 Pool Filter - Replace

History: Replaced in 2021.

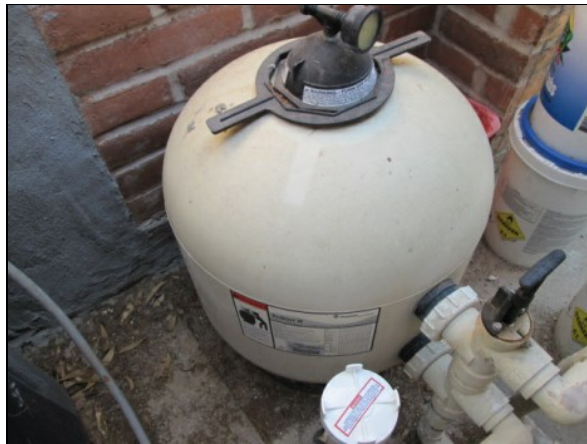
Comp #: 1221 Spa Filter - Replace

History: Replaced in 2013.

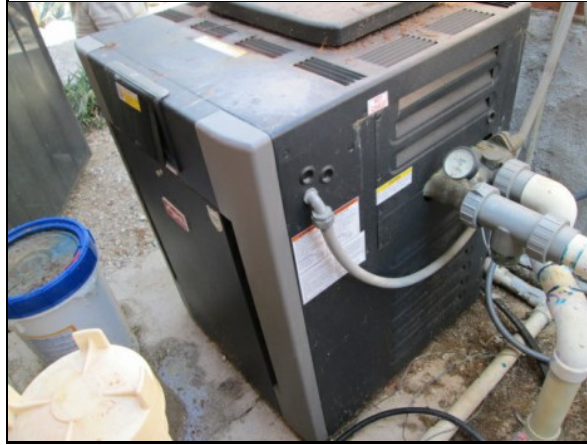
Comp #: 1222 Pool Heater - Replace

History: Replaced in 2021 for \$5,875. Previously replaced in 2007.

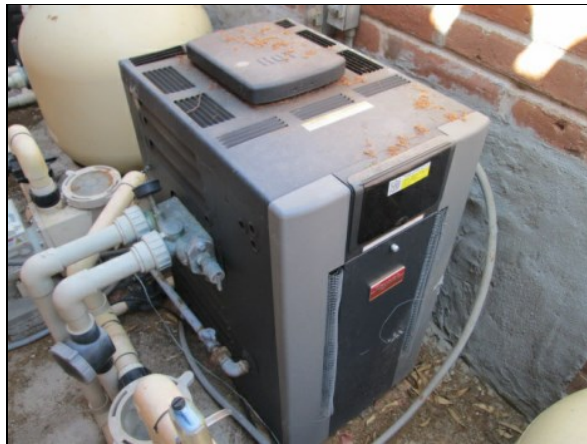
Comp #: 1223 Spa Heater - Replace

History: Replaced in 2021 for \$2,994. Previously replaced in 2006.

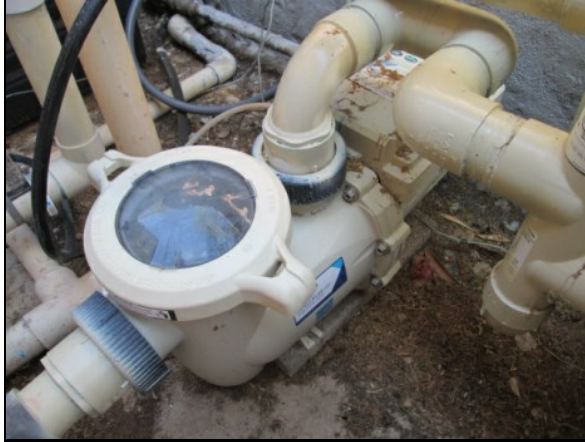
Comp #: 1224 Pool/Spa Pumps - Replace

History: Replaced pool pump and installed (2) VFD spa motors in 2024 for \$4,671. Replaced spa pumps in 2018.

Comments: These are variable-speed pumps. They are assumed to be functional with no issues reported. The spa pumps are older (2018), but should last longer than the VFDs, so replacement has been scheduled with the new pool pump. Periodic repair and motor replacement should be addressed as a maintenance issue. This component funds for replacement of the pump and motor assembly.

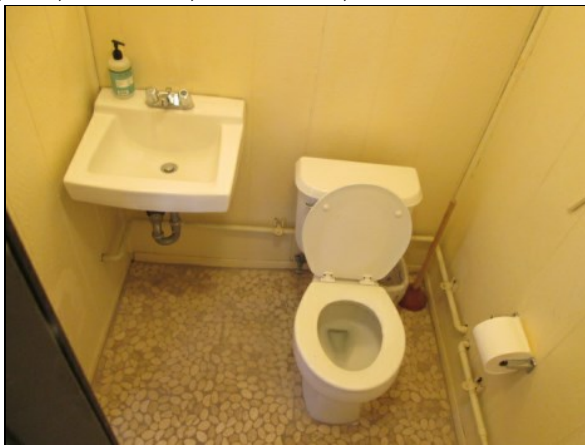
Comments: Appear to be in nice shape overall. This component funds to remodel the restroom and shower, which includes replacement of the lighting, sink, toilet, tile surfaces, shower faucet, etc.

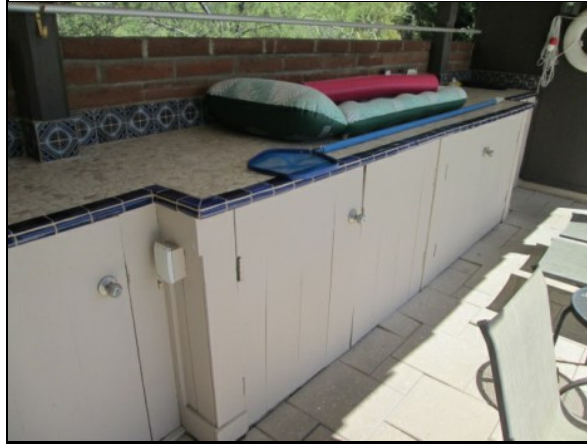
Comments: Appears to be intact and functional. This component funds to remodel the pool building cabinetry, which includes replacement of the cabinetry and countertops.

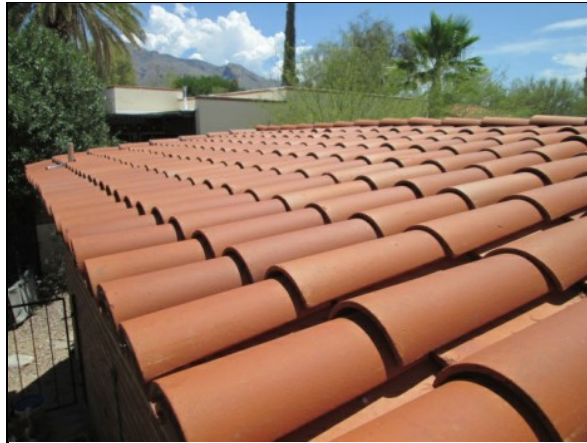
Comp #: 1290 Tile Roof - Replace

Comments: This is a clay tile roof system. Tiles appear to be intact. Underlayment is the true waterproofing component of this roof. Although it is not visible to inspect, replacement will be needed to keep the roof watertight. Clay tiles get brittle over time and a large portion will be damaged during removal to replace the underlayment. Complete replacement of this roof system should be planned. Life span will vary depending on the quality of underlayment installed as well as regular roof maintenance.

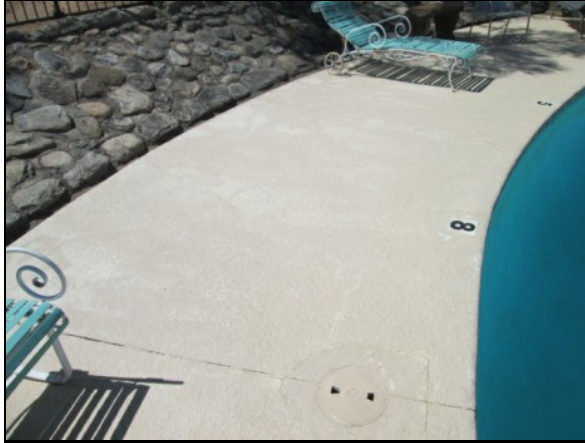
Comments: This is an acrylic kool deck. Appears to be intact with no significant cracking or damage evident. This component funds to periodically grind off the existing deck coating and re-apply a new surface. Combined cost with the seal/repair component accounts for the total estimated resurface budget.

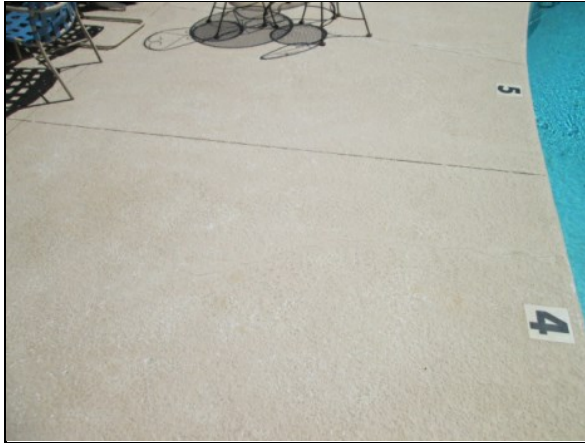
Comp #: 1201 Pool Deck - Seal/Repair

Comments: Some cracking, staining and discoloration evident mainly near the pool steps. This component funds to periodically patch cracks and seal/paint the deck to cover stains and restore the appearance.

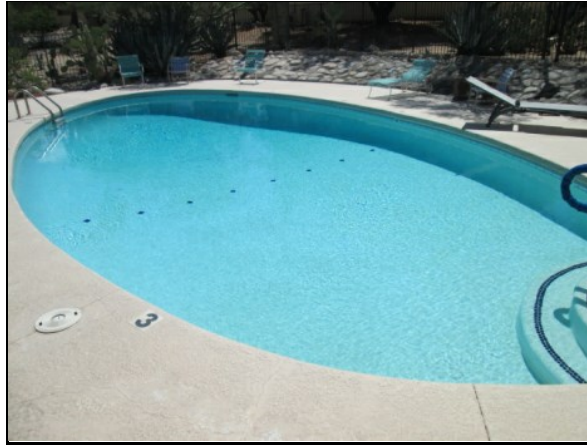
Comments: The pool has a plaster surface with waterline tile. Some discoloration was noted. We are not sure if this pool has been resurfaced again since around 2006. If it is the same surface, then it has held up well. Plaster surfaces are not expected to last as long as pebble surfaces. This component funds to resurface with plaster.

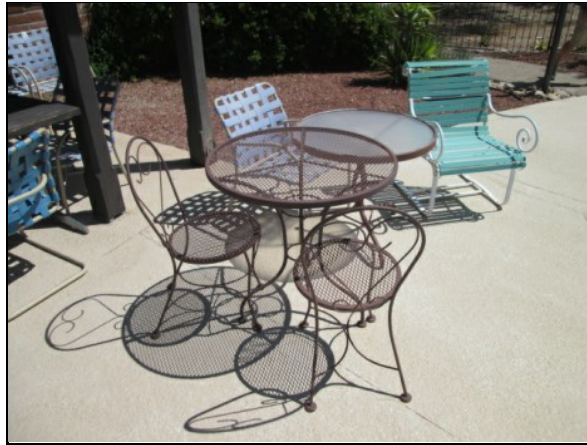
Comp #: 1204 Pool Furniture - Replace

Funded?: No. Pool furniture will reportedly be replaced as needed with Operating funds.

Comments: Quantity includes (3) sling lounges, (1) metal lounge, (4) concrete benches, (1) wood bench, (16) sling chairs, (6) metal chairs, (2) benches and (3) dining tables. Varying conditions observed. There is no expectancy for complete replacement. Funding is provided for periodic, partial replacement.

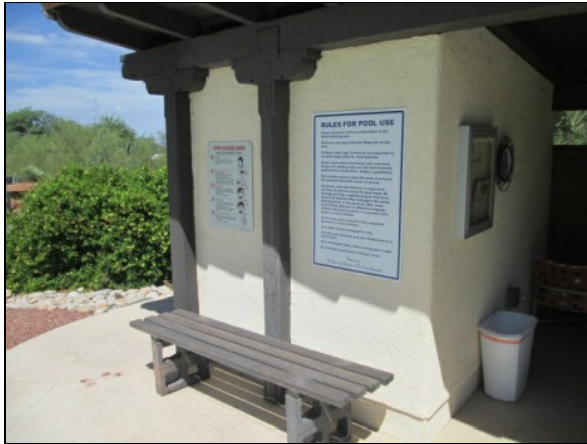
Comp #: 1214 Pool Building - Repaint/Repair

Comments: Surfaces appear to be uniform and in nice shape overall. This component funds to periodically repaint and repair the pool building.
